# **SOLAR THERMAL COLLECTOR INSTALLATION REPORT**

**Location:** Katunje, Dhading

**Customer:** Future Village Charity Foundation

**Date of installation:** 8<sup>th</sup> May 2012 – 12<sup>th</sup> May 2012

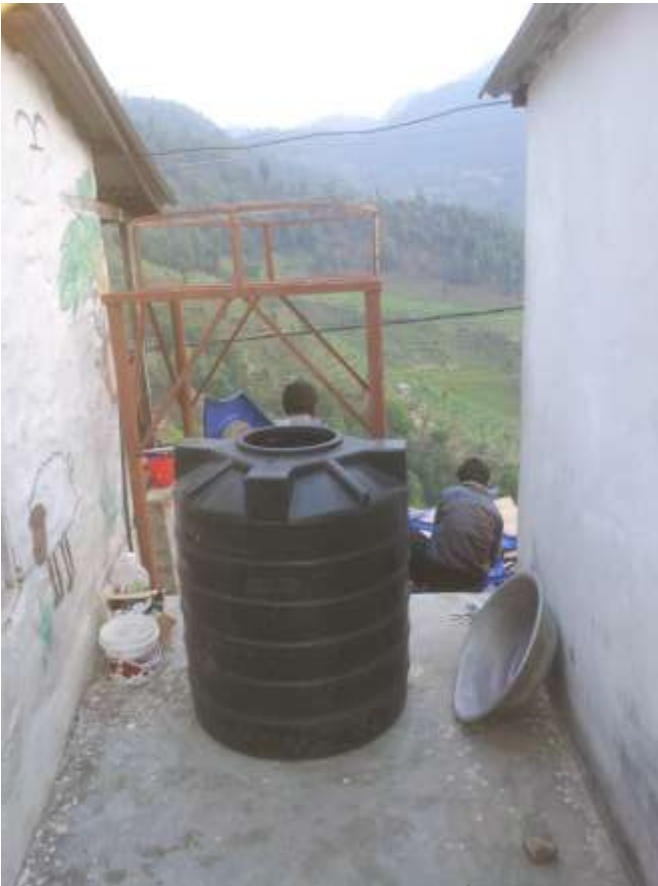
Picture 3: Tank stand was installed

We had to break off some concrete to make sure that the tank stand and the solar water tank could fit at the top of the bathroom together. Once that was done, we quickly assembled the solar water heater support structure. Then we moved on to piping. PPR pipes were used for piping and proper valves were installed to control the flow of warm and the cold water.

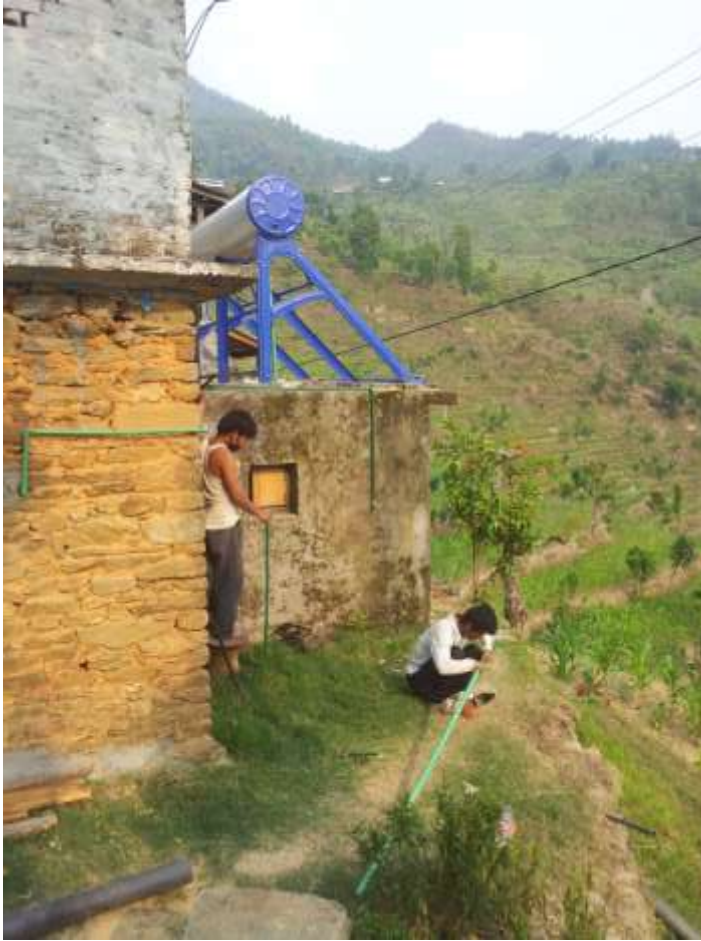
Picture 4 External outlets for hot and cold water

An external outlet for hot water and another one for cold water were installed. A wash-basin was installed for the cold water outlet as well. Another pipe was supplied to the kitchen, thus replacing the loose pipe that was installed there earlier.

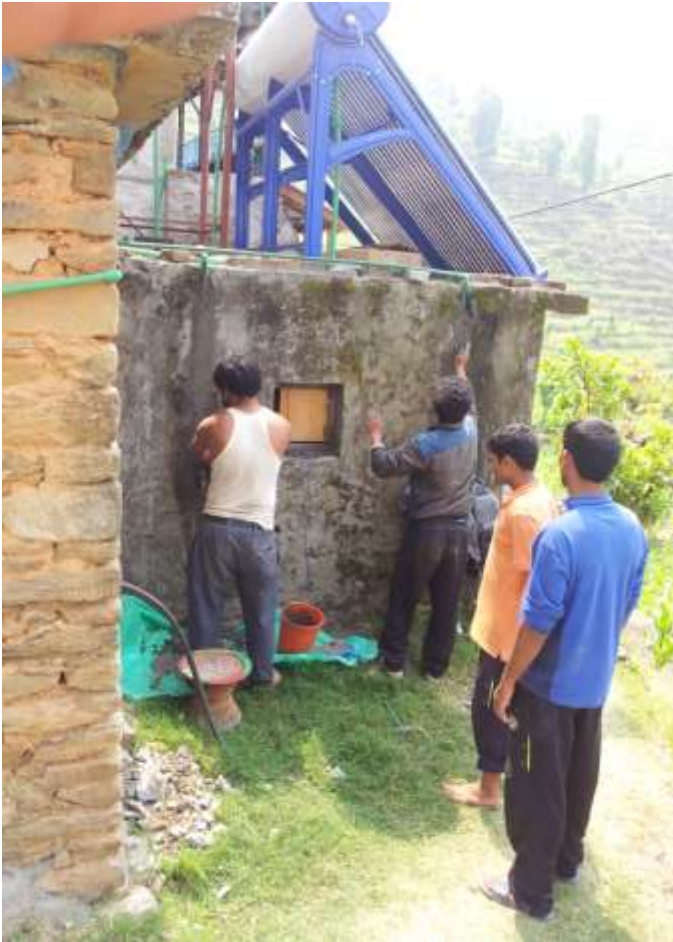
Picture 7: Covering the pipes with cement

Procuring the cement was a big hassle because of the strike, but with the help of Dambar's contacts we finally managed to get hold of the cement. All the pipes and the broken tiles were then covered with the cement.

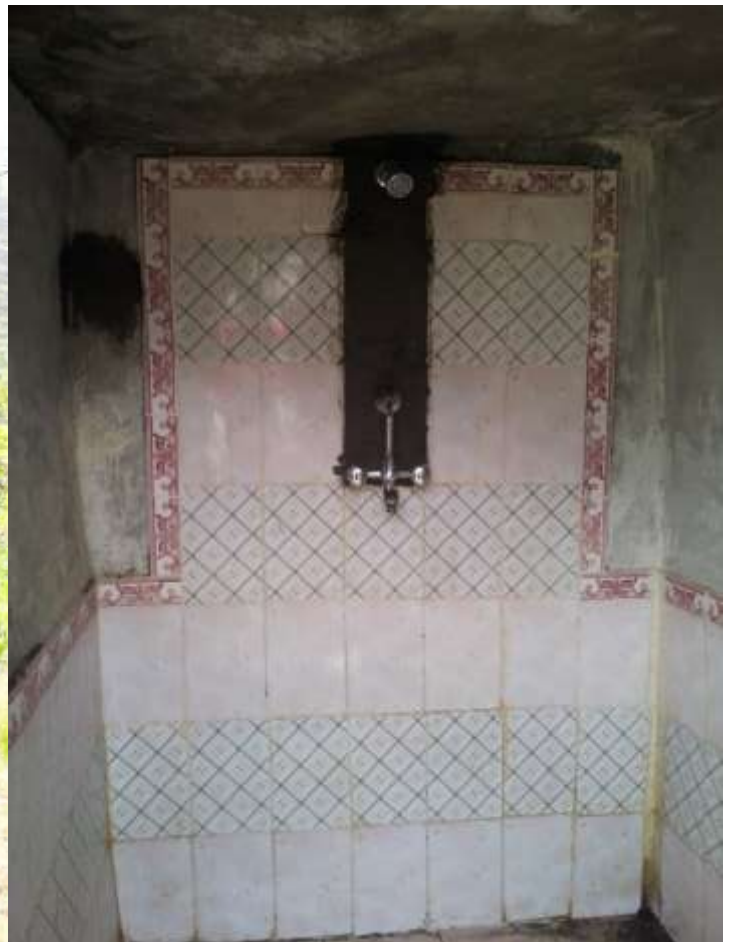
Picture 6: The mixture supported with cement

Once the cement was set, the hot and the cold water mixture was fixed. We checked the water pressure from the shower and there was a substantial increase in the pressure compared to the last instance when we visited the school. So, we decided against using the electric pressure motor at the shower head and instead connected it to the black tank (500litres) on top of the tank stand. Because of the increase in height of the water-tank because of the tank stand, the natural water pressure was not sufficient to fill the tank. So, we figured that the motor was of more use there.
